Flexible Water Heater Connectors with Black, Rubber Lining

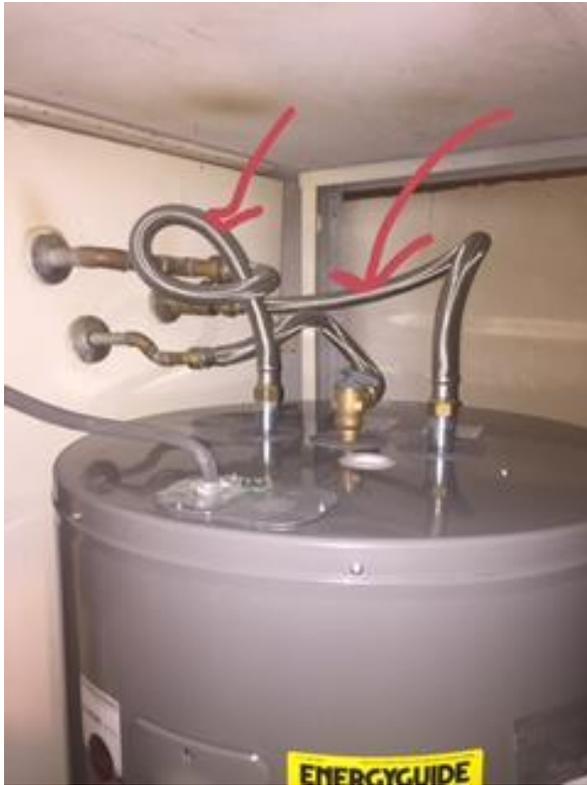
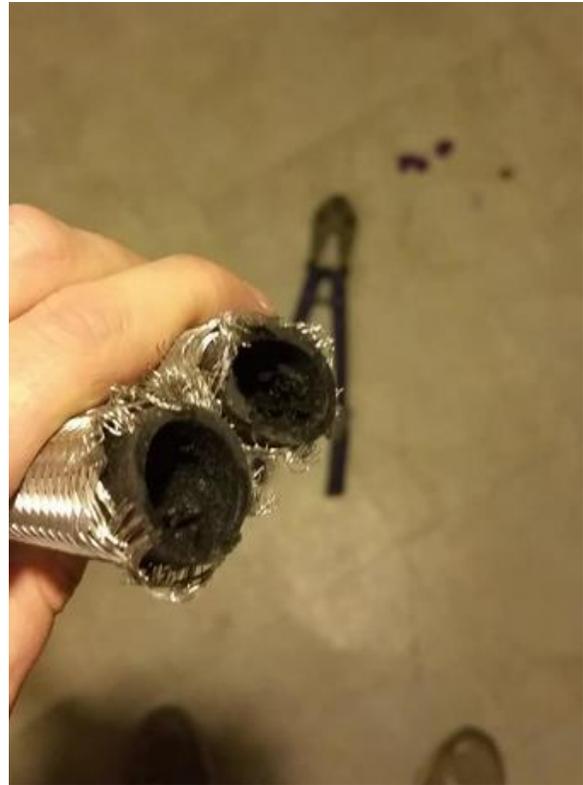
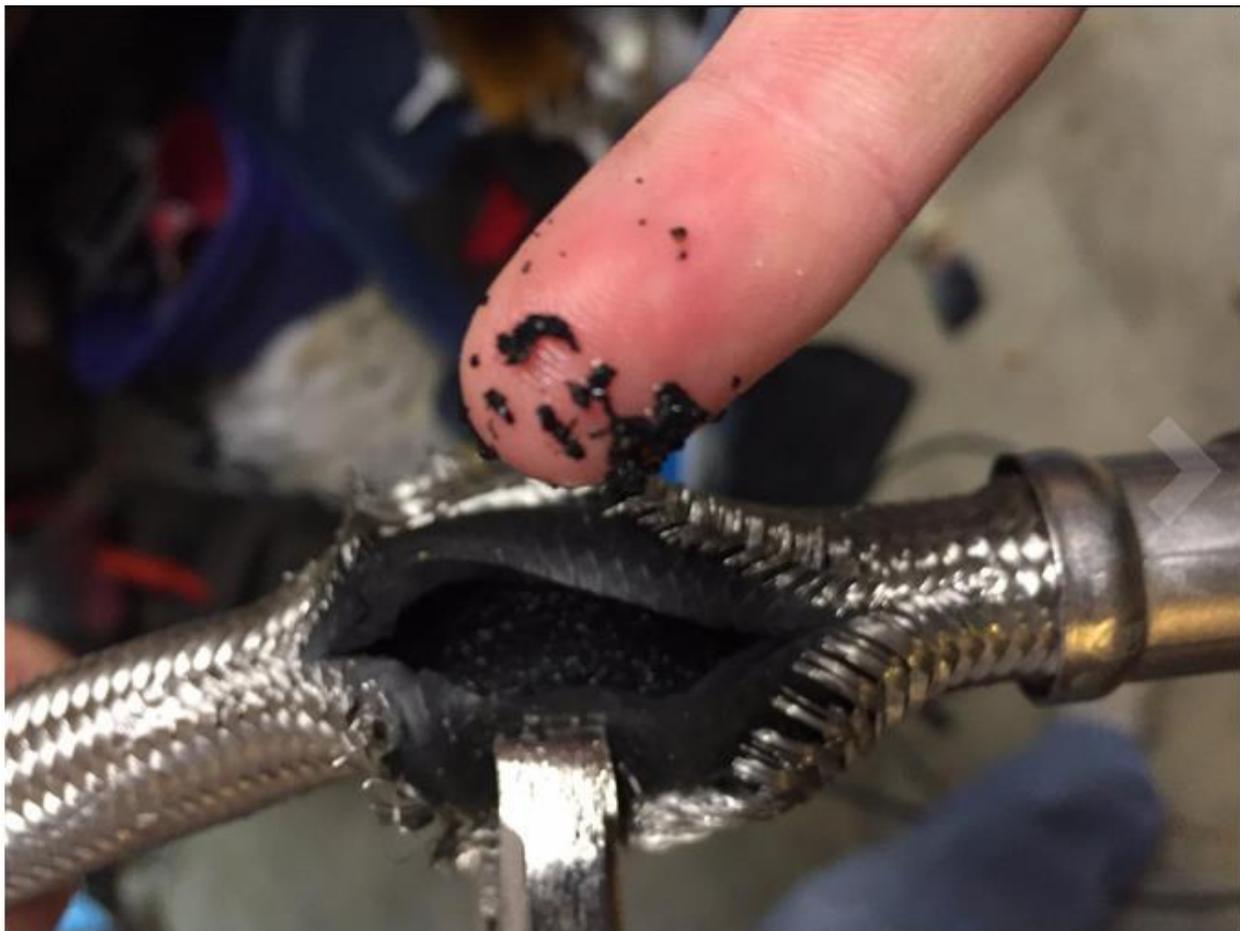
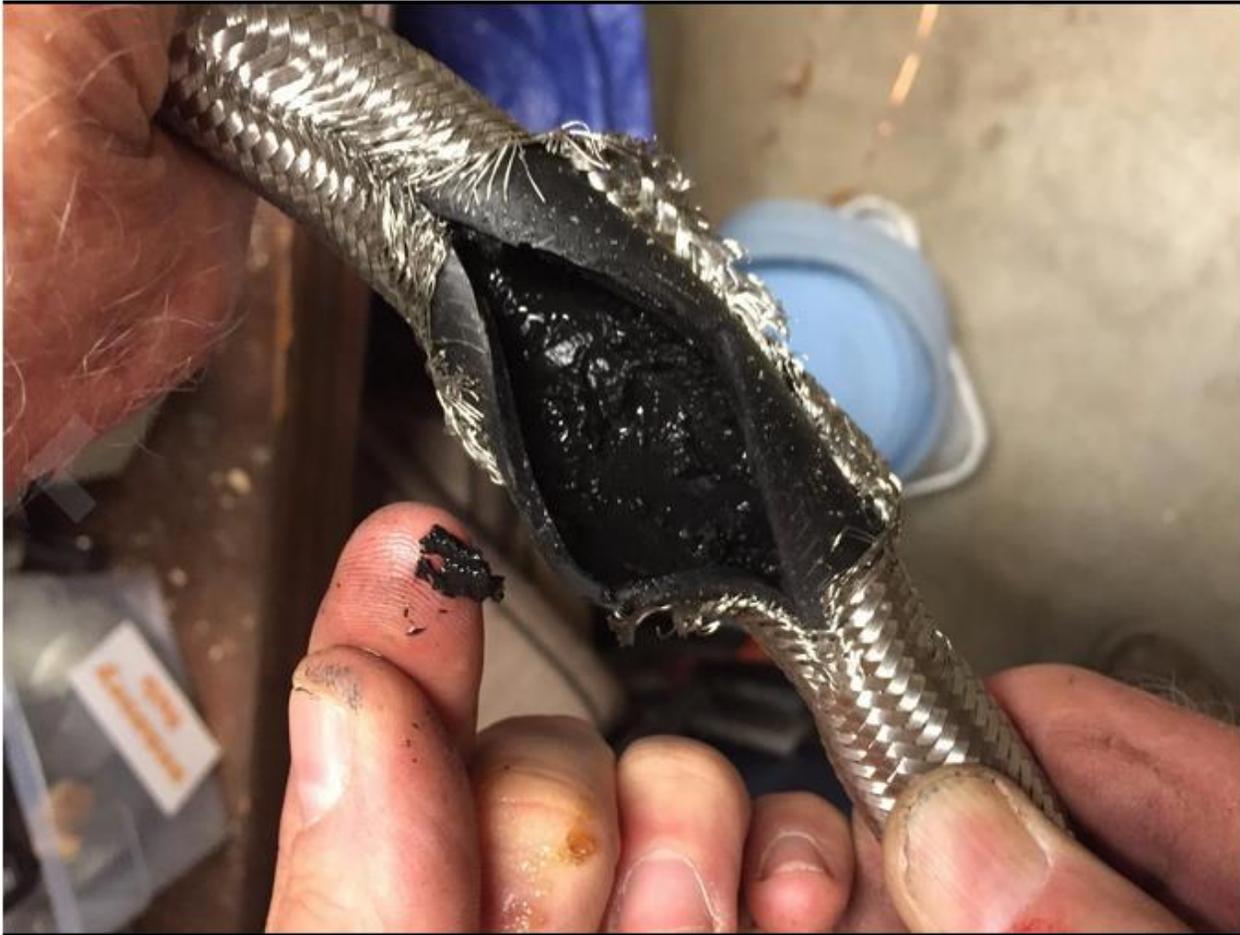
Online reviews and forums of certain flexible, push-to-connect braided, stainless steel water heater connectors have reported that those with a black, rubber-like internal lining breakdown after 6 months to 2 years. Pieces of the rubber lining, which look like black flecks floating in water, end up in the bathtub, shower, washing machine, etc. They can also collect inside of faucet aerators. The black flecks can smear when touched and leave greasy streaks in sinks, bathtubs or other fixtures and appliances. Customers should contact the manufacturer of the flexible hose connector for recommendations on a replacement. In addition, customers should consider “hard piping” the hot water heater or other brands of flexible connectors with no liner or a different liner material to address the issue.
